**UNITED STATES ENVIRONMENTAL PROTECTION AGENCY**

**Re: Arconic/Alcoa West Plant – Massena, 45 County Route 42 (Park Ave East)  
EPA Inspection August 30 to September 1, 2017  
SPDES Permit No: NY0001732**

## Water Compliance Inspection Report

<b>Compliance Evaluation Inspection – Massena Operations – Alcoa/Arconic West Plant</b>	
<b>Inspection Date:</b> August 30, 2017 to September 1, 2017 <b>Inspection Time:</b>	<b>EPA Representatives:</b> Murray Lantner, P.E. Environmental Engineer, USEPA Region 2, (212) 637-3976, <a href="mailto:lantner.murray@epa.gov">lantner.murray@epa.gov</a> Peter Bahor, Enforcement Officer, USEPA-HQ, (202) 564-7029, <a href="mailto:bahor.peter@epa.gov">bahor.peter@epa.gov</a>  <b>New York State Department of Environmental Conservation, Region 6 Representative</b> David Rarick, P.E. Environmental Engineer II, 317 Washington Street, Watertown, NY 13601 (315) 785-2513 (office), <a href="mailto:david.rarick@dec.ny.gov">david.rarick@dec.ny.gov</a>
<b>On-Site Arconic or Alcoa Representatives:</b> Tim Long – (315) 764-4914 (office), (315) 842-1783 (cell) – <a href="mailto:Tim.Long@arconic.com">Tim.Long@arconic.com</a> Todd Furnia (315) 764-4916 (office) (315)

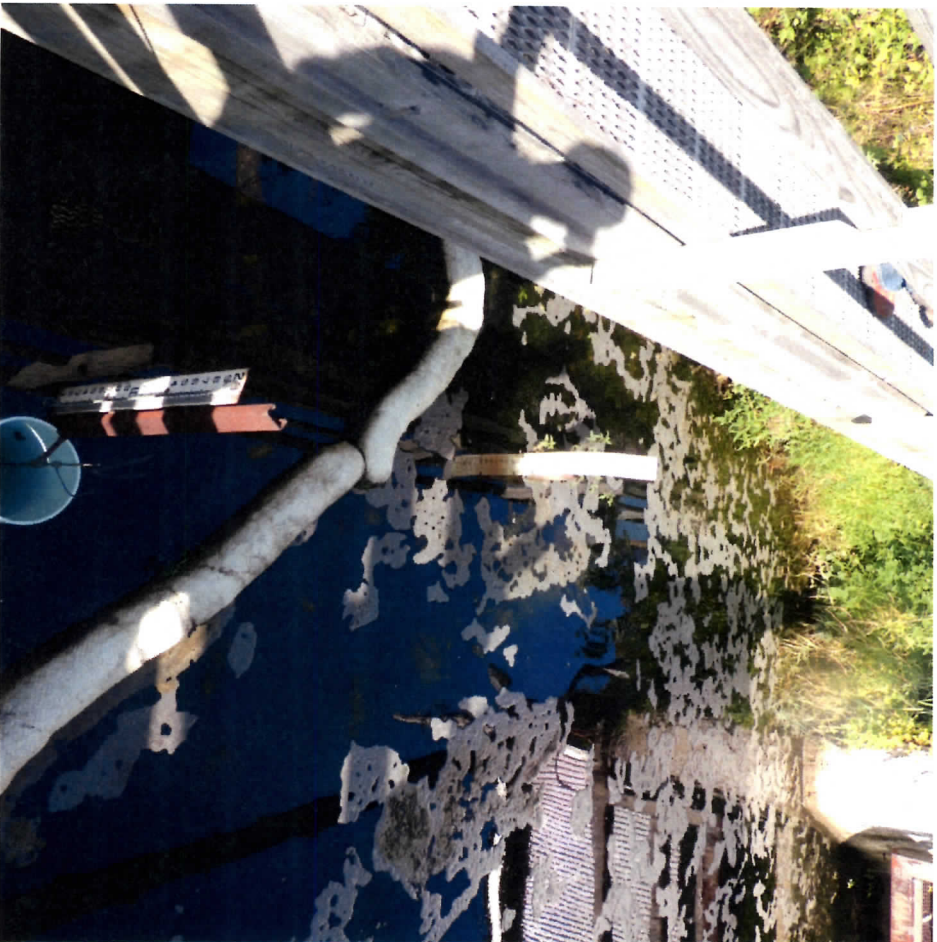
DSCN4857 – some foam/scum prior to outfall 001 weir

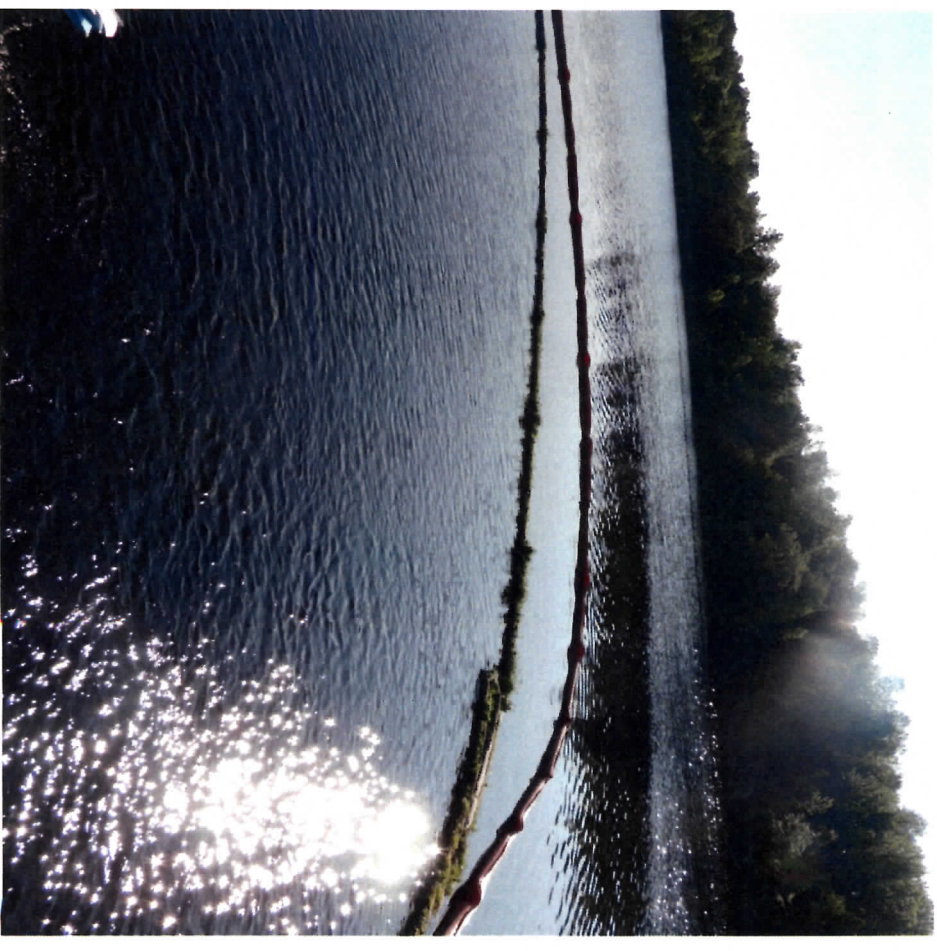
Outfall	Observation	Photos	Area of Concern (Y or N)
001	<p>As shown in photograph 858, Attachment 1A, the boom at Outfall 001 was said to be changed quarterly. As shown in photo 858 the inner boom had much vegetative growth. Please verify the cleaning and changing frequency for the booms.</p> <p>Alarm for outfall (dialer) has been disconnected because control room was receiving unwarranted alarms. Paper rolls in flow were missing since Feb. 2017 for the river monitor.</p>	858	<p>Y – Alarm Dialer disconnected.</p> <p>Frequency of boom maintenance</p>
003	Outfall 003 (18" Parshall Flume) had two head sensors to measure submerged flow Ha/Hb. The flow charts for the outfalls did not include a chart for head and submerged head, only a chart based on the head in the converging section of the flume. Does	859 to 861	Y – Does diverging section of flume become submerged?

DSCN4858 – 001 Outfall Booms in Grasse River

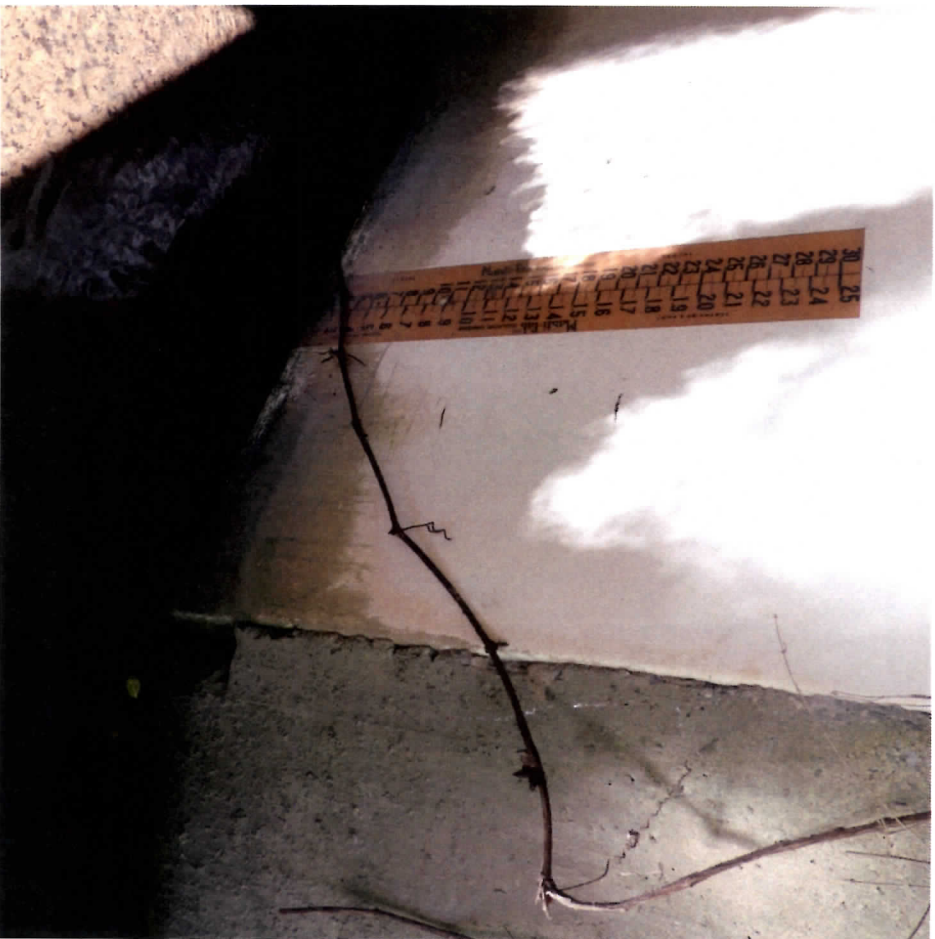
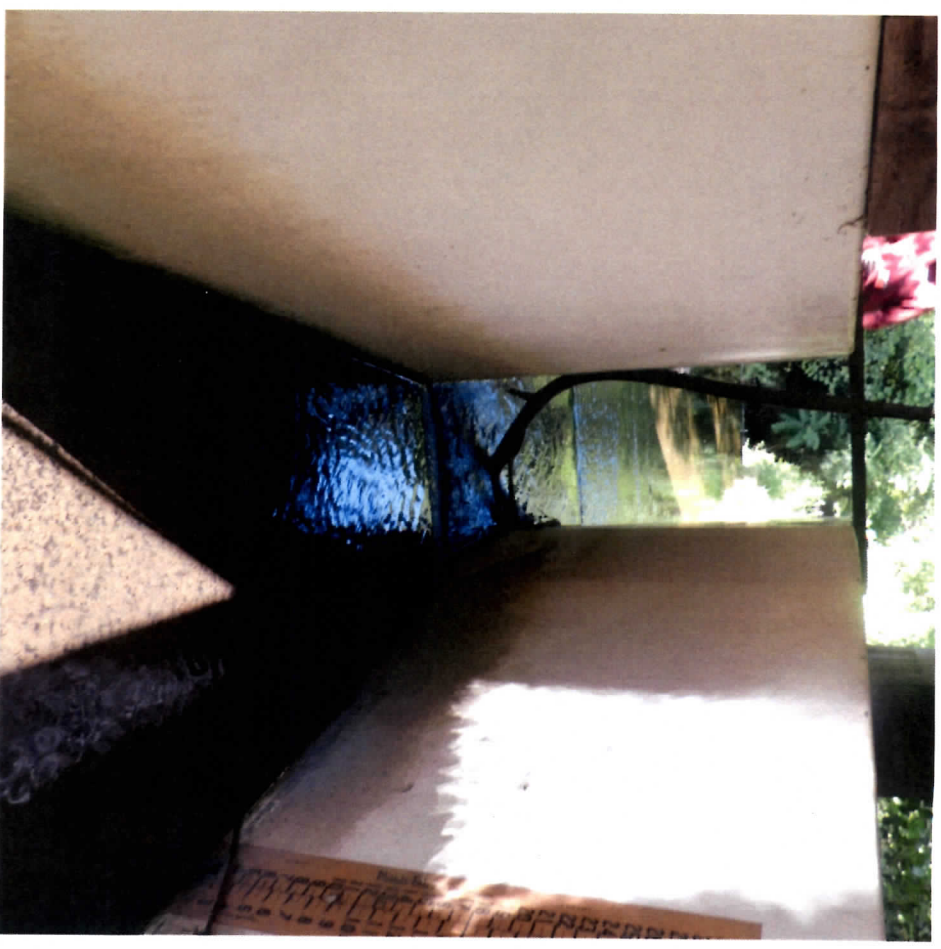
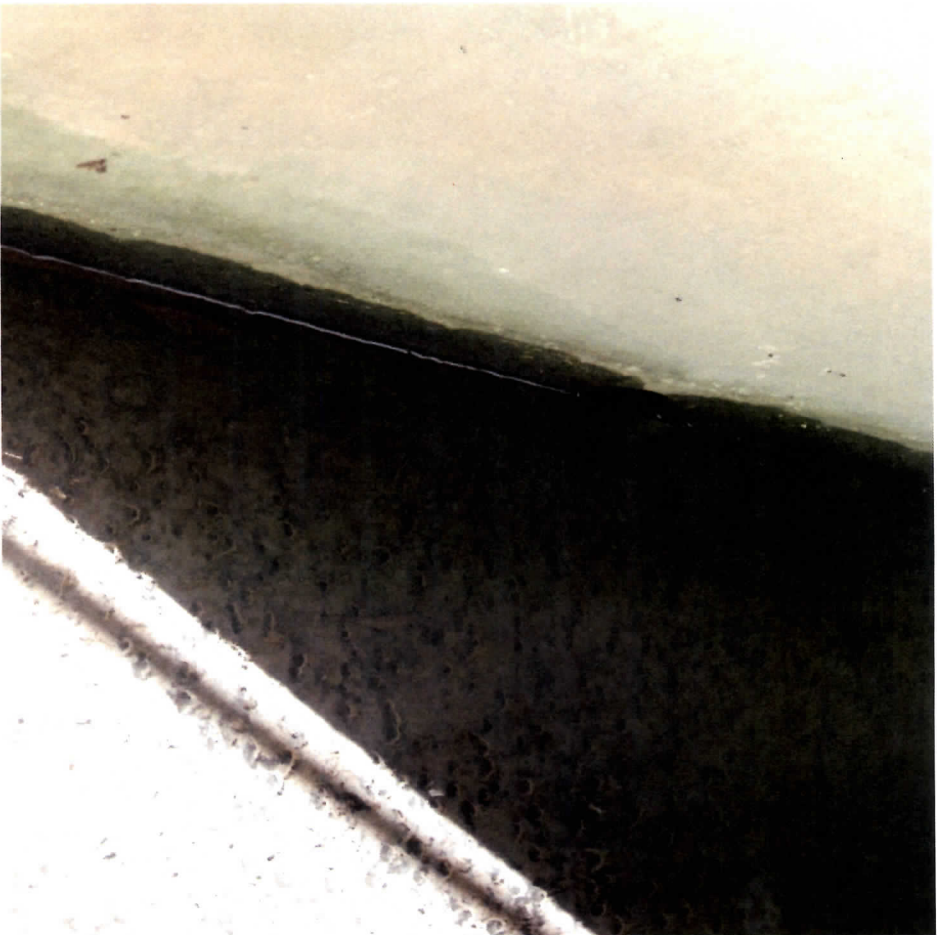
Outfall	Observation	Photos	Area of Concern (Y or N)
	this outfall become submerged? If so does the flow program at 003 take submergence into account?		
01A	Free of Foams and Sheen, 18" Cipolletti Weir (head 0.455') flow measuring 710 gpm consistent with flow chart for this type of Weir		N
01F	Clarifier for cyanide and fluoride wastewaters from on-site. Was not treating wastewater at the time of the inspection. Arconic representatives said that Pot Pile A wastewater collection is shut down from June to October 1. Indicated that the 01F treatment plant was built in 1994 and are planning to upgrade this facility (what is status of upgrade)?	871, 872	Y – Status of Wastewater Treatment Plant upgrade for 01F?
01D	No flow at the time of the inspection. Backwash tank was still flowing. Potassium Permanganate pump was broken. Waiting for parts. Feeding potassium at a different location (Building 79) (01B and 01F)		Y – Status of Potassium Permanganate Pump

DSCN4859 - Outfall 003 – Parshall Flume (staff gauge)

DSCN4860 - Outfall 003 Parshall Flume

Entrance to Stilling Well to measure head at Outfall 003  
DSCN4861

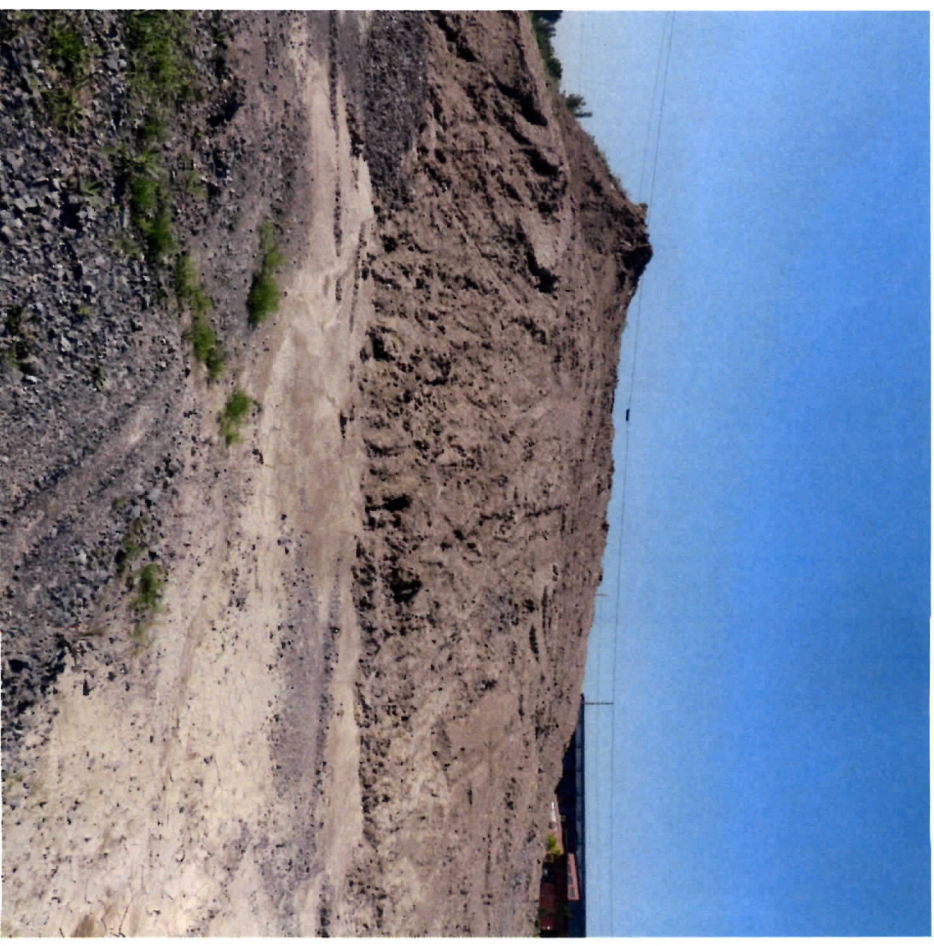
DSCN4866 – Material storage pile in ROPS area pile to be used for fill for cover material by remedial group

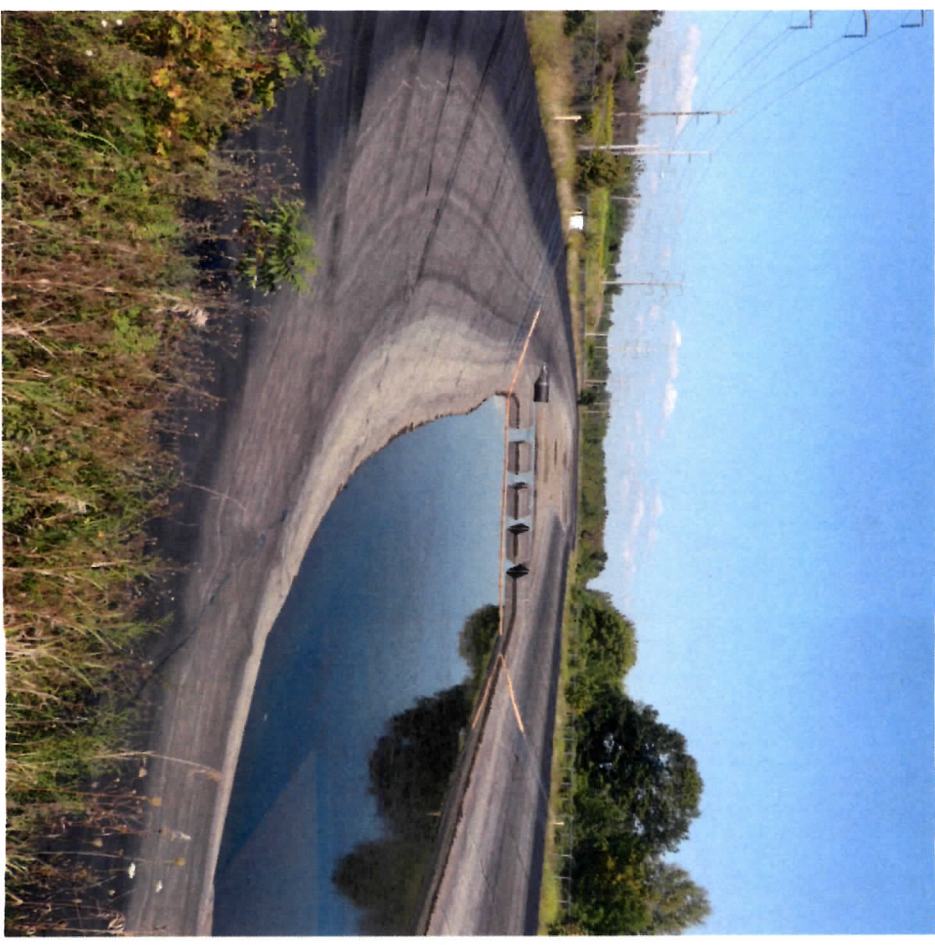
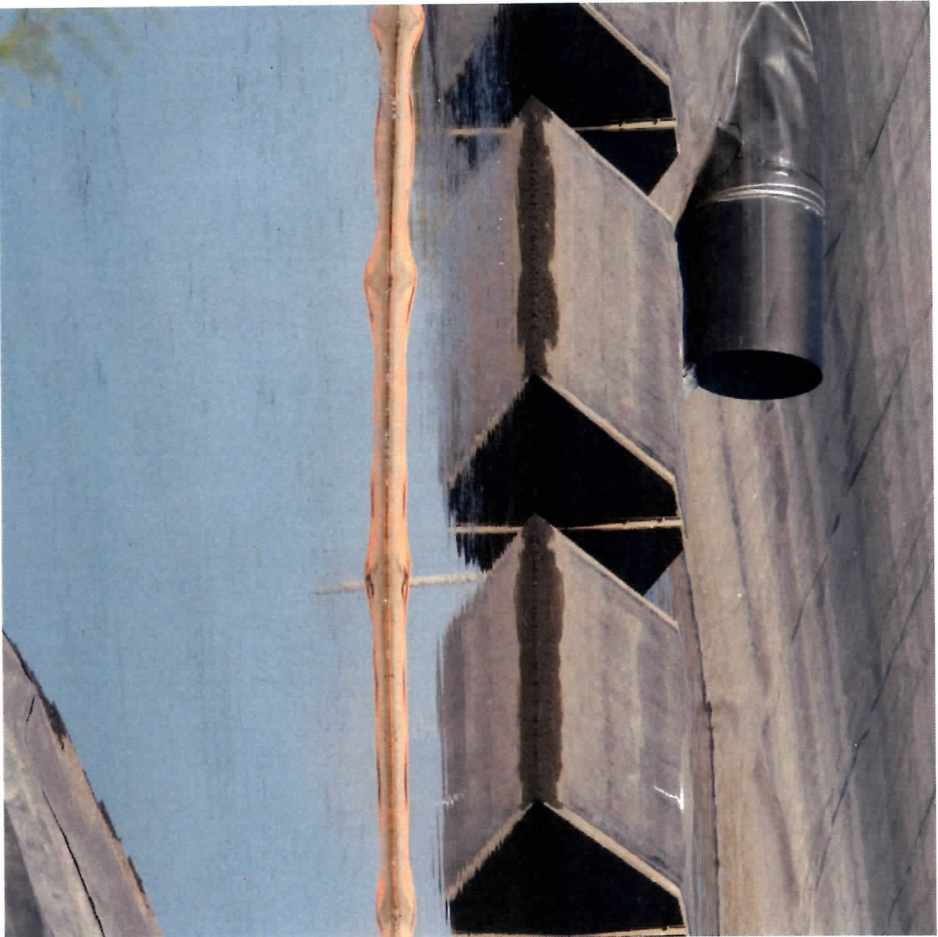
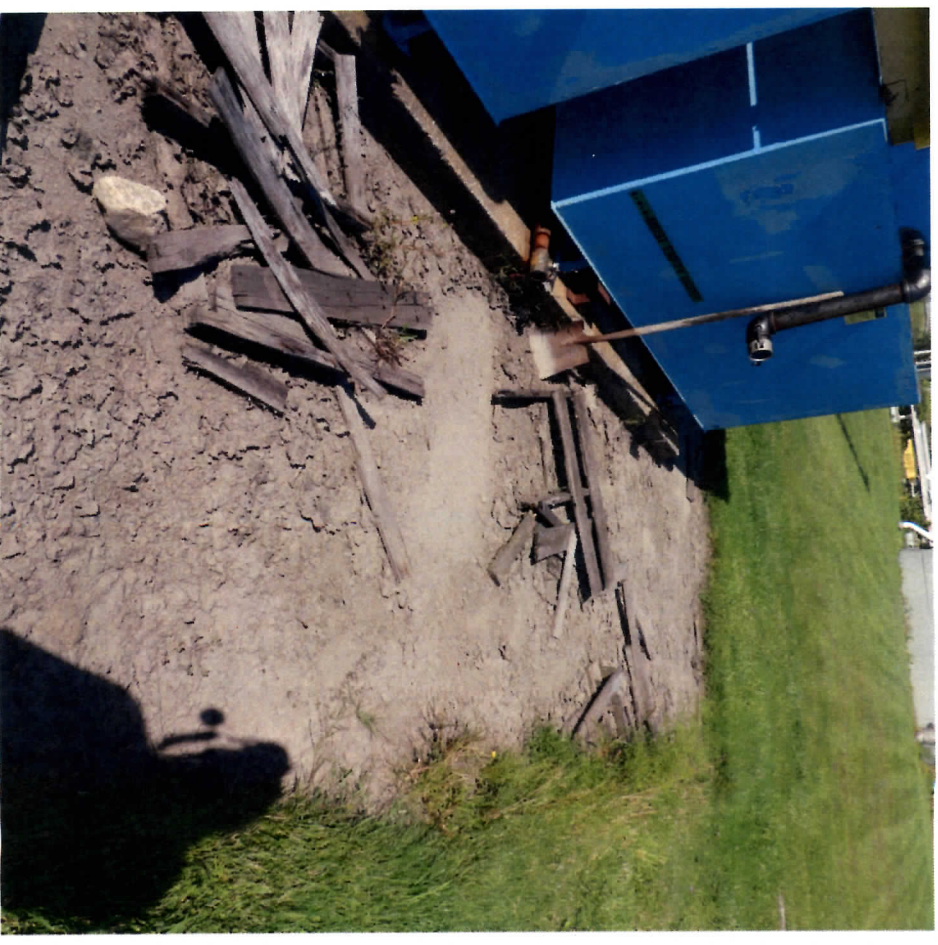
9. The Outfall 004/005 Impoundment (photos 882 to 884) was said to be designed for a 19 year storm, and overflows at a height of 17'. Based on the letter from Arconic (excerpt below) it overflowed in July 2017. The letter indicated that there was a violation due to dewatering of central impoundment as well. Special Condition O of the Permit authorizes discharges from 005 and bypasses of the 004 carbon unites when stormwater runoff exceeds the design storm. The design storm was thought to be a 19 year storm. Please verify whether the 004/005 system is designed to handle the 25 year storm, or if additional capacity is needed in this system.

DSCN4882 – 004/005 impoundment

DSCN4883 – 004/005 impoundment

DSCN4884 – 004/005 impoundment.

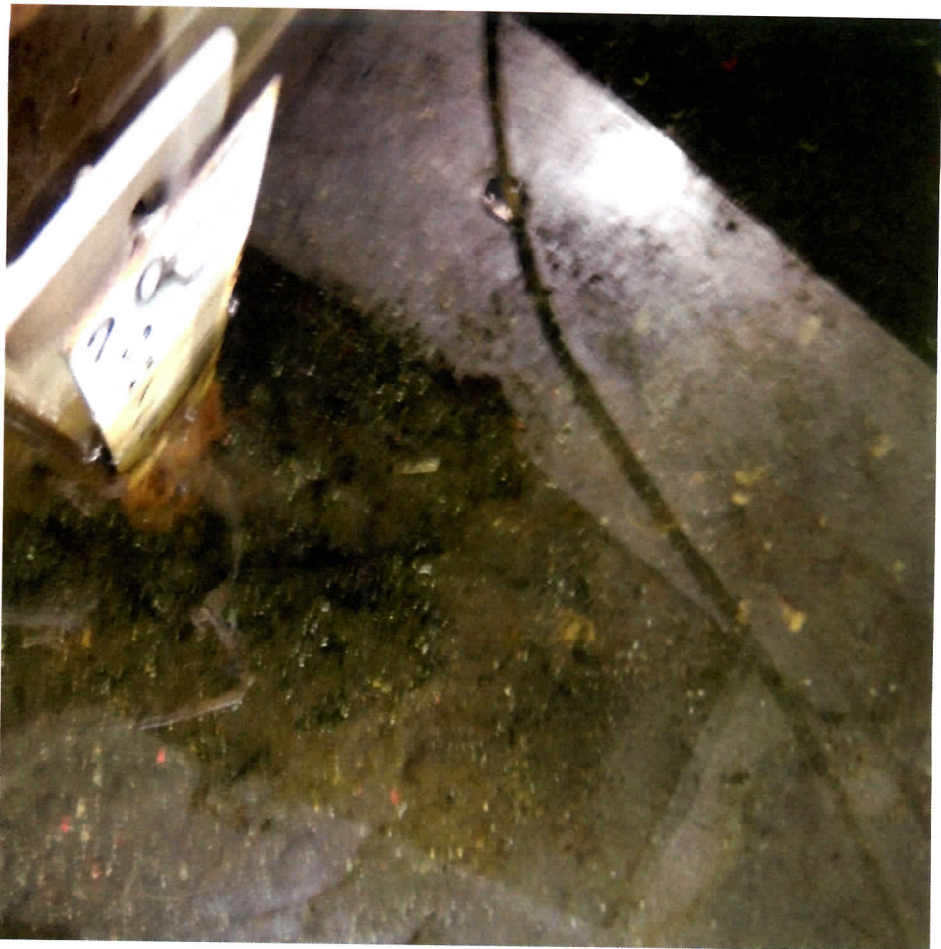
01B	Oil Wastewater Treatment – Area III O/W separator.		N
004	<p>Pump 1 VFD was out of service. Said that there was a replacement available and new pump would be installed the following week.</p> <p>Arconic representatives indicated that they are considering additional treatment for 01G or expanding the 004 lagoon.</p> <p>As shown in Photo 884 in Att. 1a there was soil and pallets at the 004/005 impoundment that should be cleaned up.</p>		<p>Y (Status of Pump 1 and other pumps for 004)</p> <p>Status of 01G treatment or 004 lagoon expansion.</p> <p>Clean up debris at 004/005 impoundment.</p>
007	No Flow through 4.5' H FLume	879, 881	N
01G	Outfall 01G (heat treat waters from Area I) was said to flow to 004 but the permit specifies that Outfall 01G flows to Outfall 001 – 01G consists of the Bldg. 131 and 140 separate discharge		Y – remove sediment from 01G-140

DSCN4885 – Outfall 01G- Bldg 140. sediment  
accumulated in need of cleaning

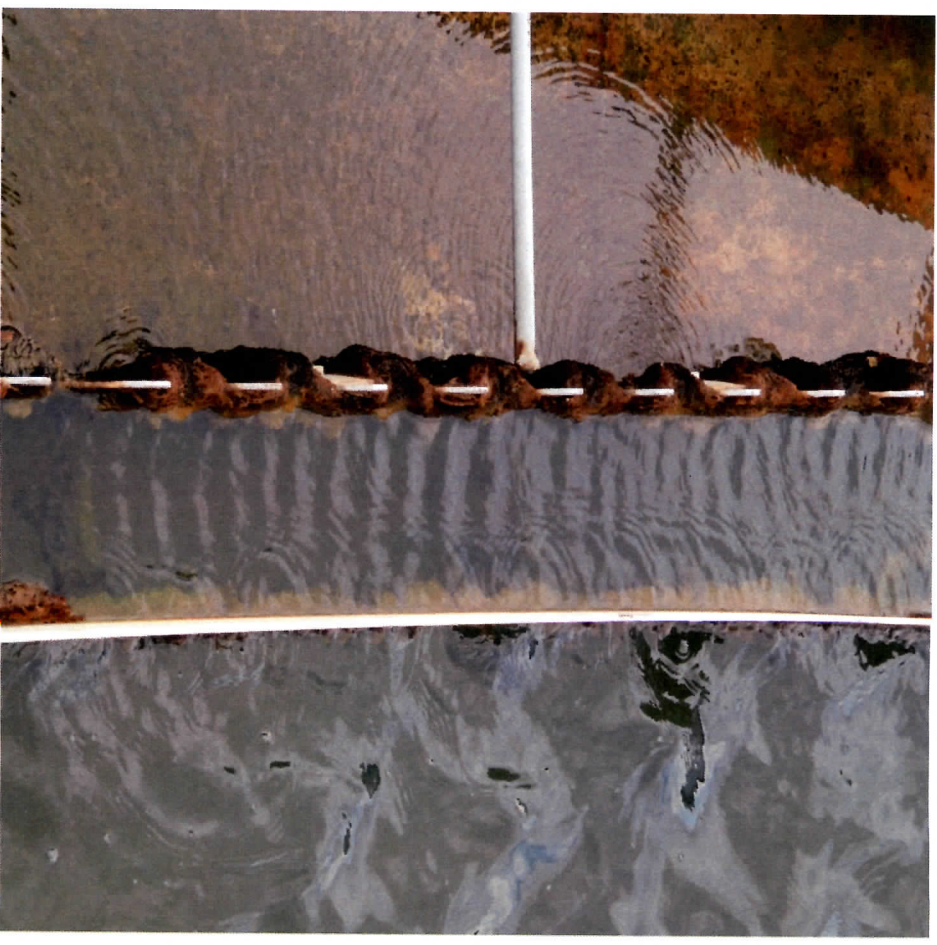
DSCN4902 – 01E clarifier, weirs have growth on them

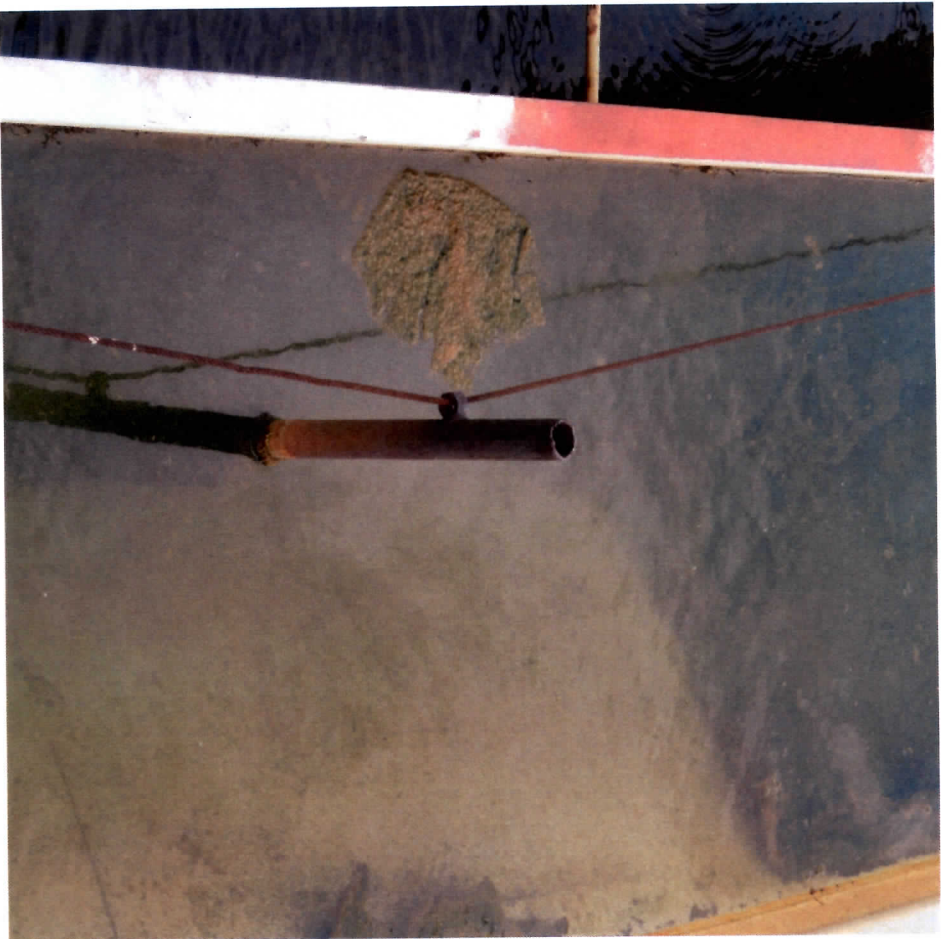
DSCN4903 – floating material on 01E clarifier

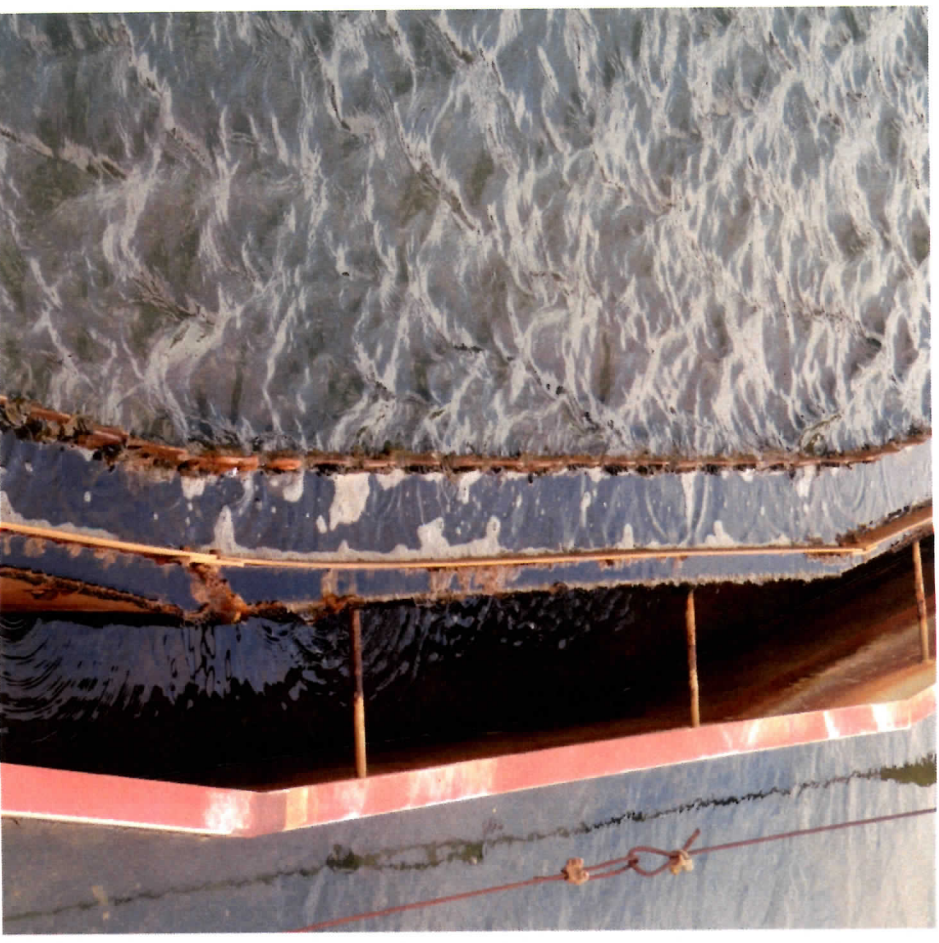
DSCN4904 – floating material/growth on weirs 01E clarifier

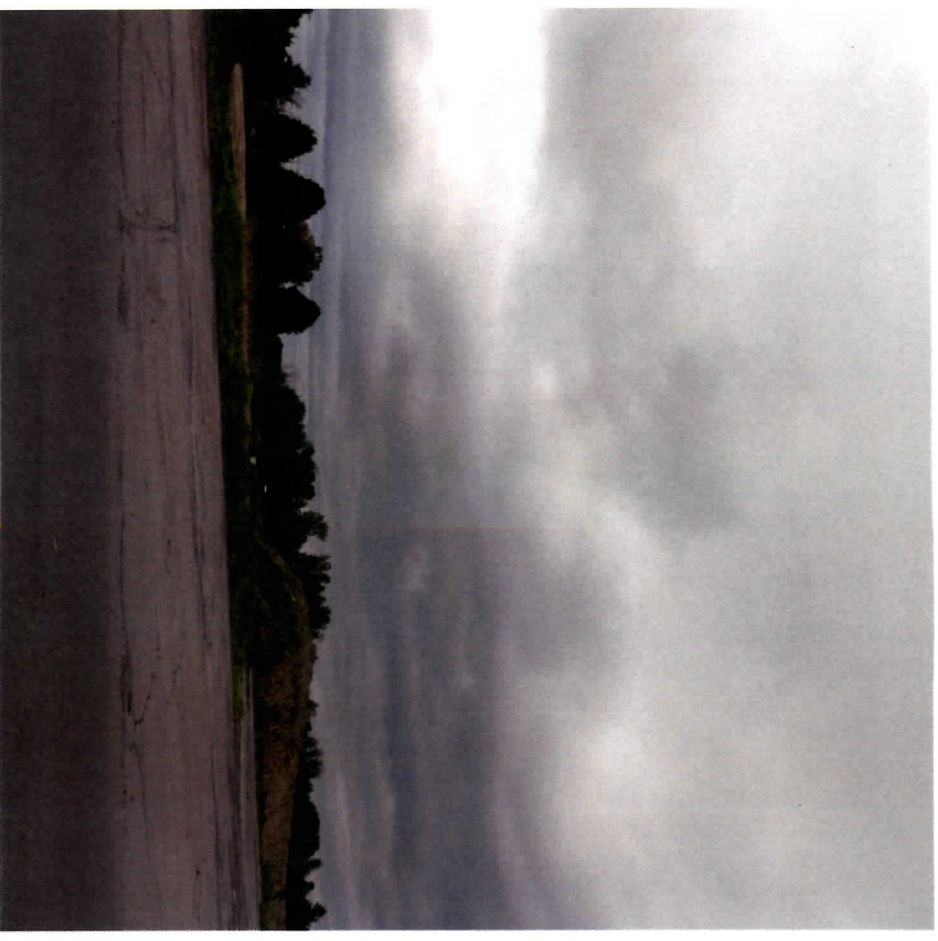
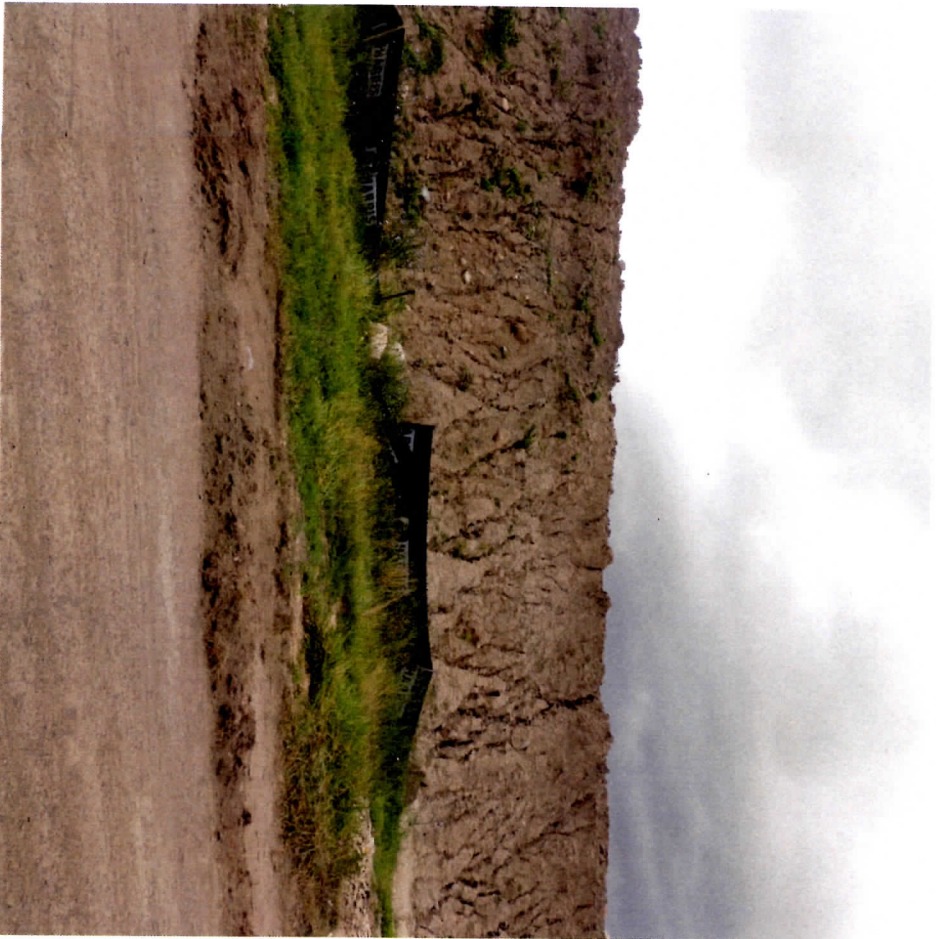
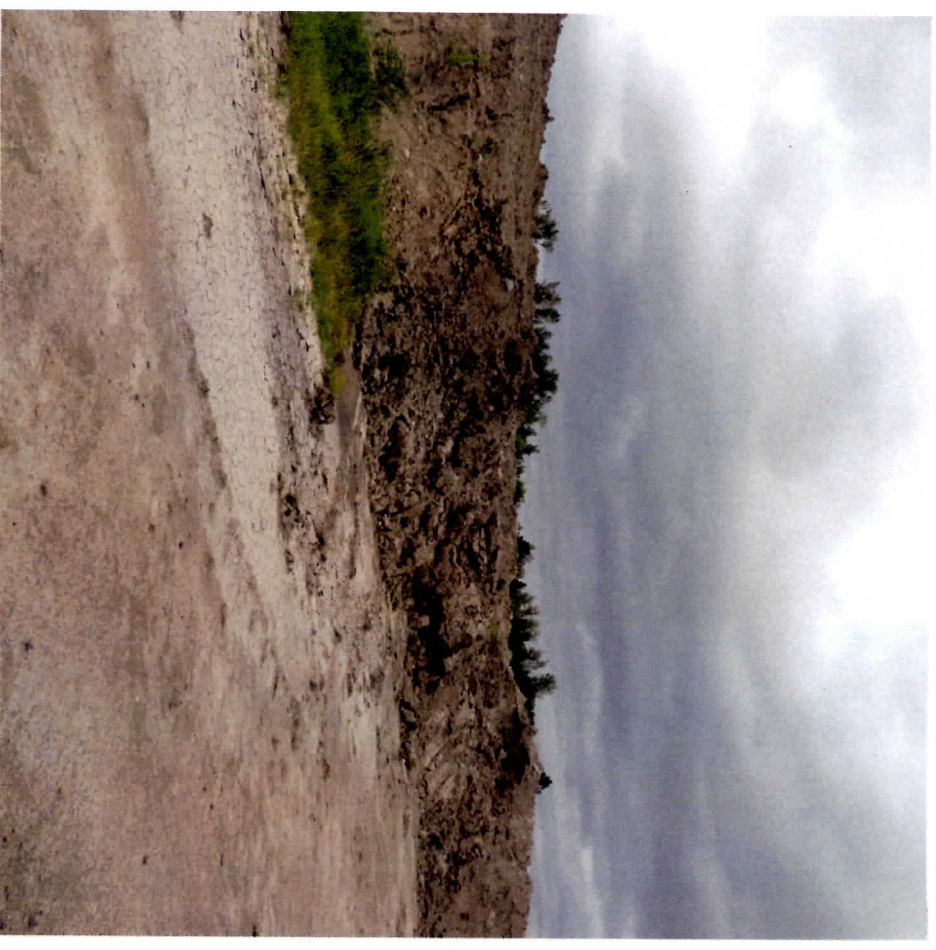
4. As shown in photographs 866, 909, 910 there are uncovered and unstabilized material storage piles. Arconic employees explained that material storage piles would be used to cover concrete areas and not be ripping up the concrete. The area that they will be applying soil was greater was estimated to be over an acre. Arconic is required to develop and implement a Stormwater Pollution Prevention Plan (SWPPP) as required by Special Condition 4.B of its Permit for construction activities 1 acre or greater. Arconic employees said that they don't need SWPPP because they will be applying the soil from the piles on top of concrete and not ripping up the concrete. However, the application of soils over an area 1 acre or greater would trigger the requirement to develop and implement a SWPPP.

DSCN4908 – material storage piles

DSCN4909 – material storage pile

DSCN4910 – unprotected material storage pile

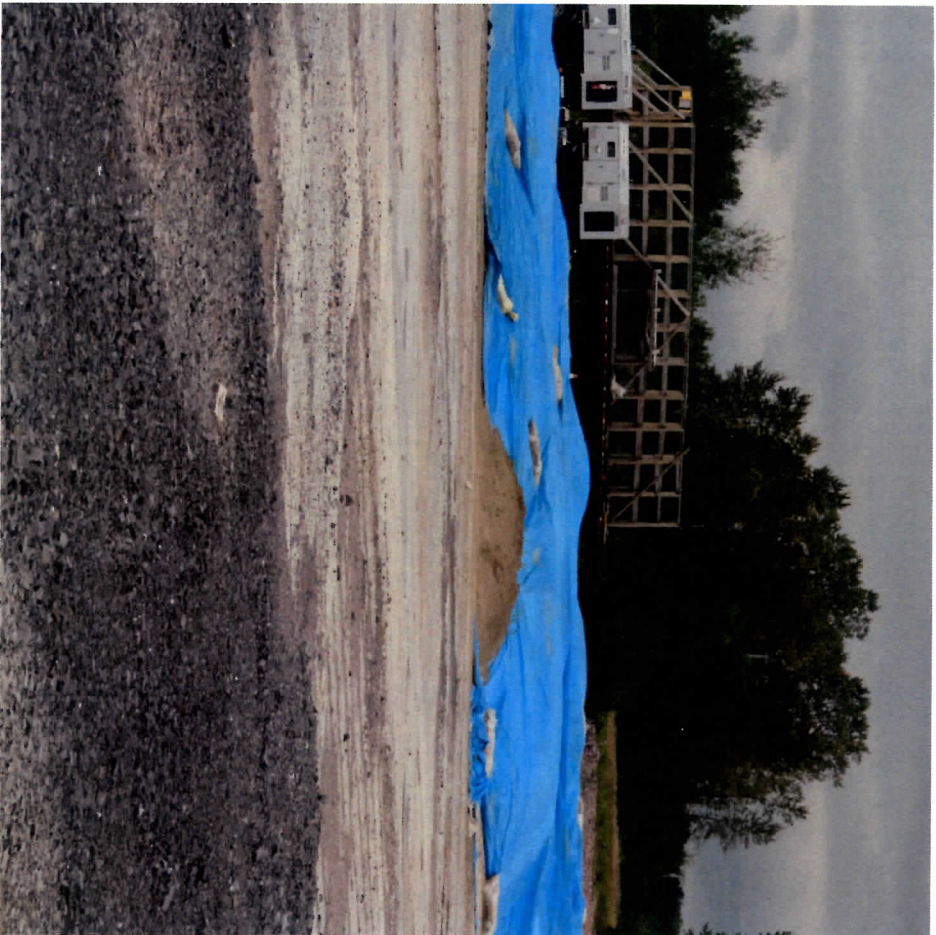
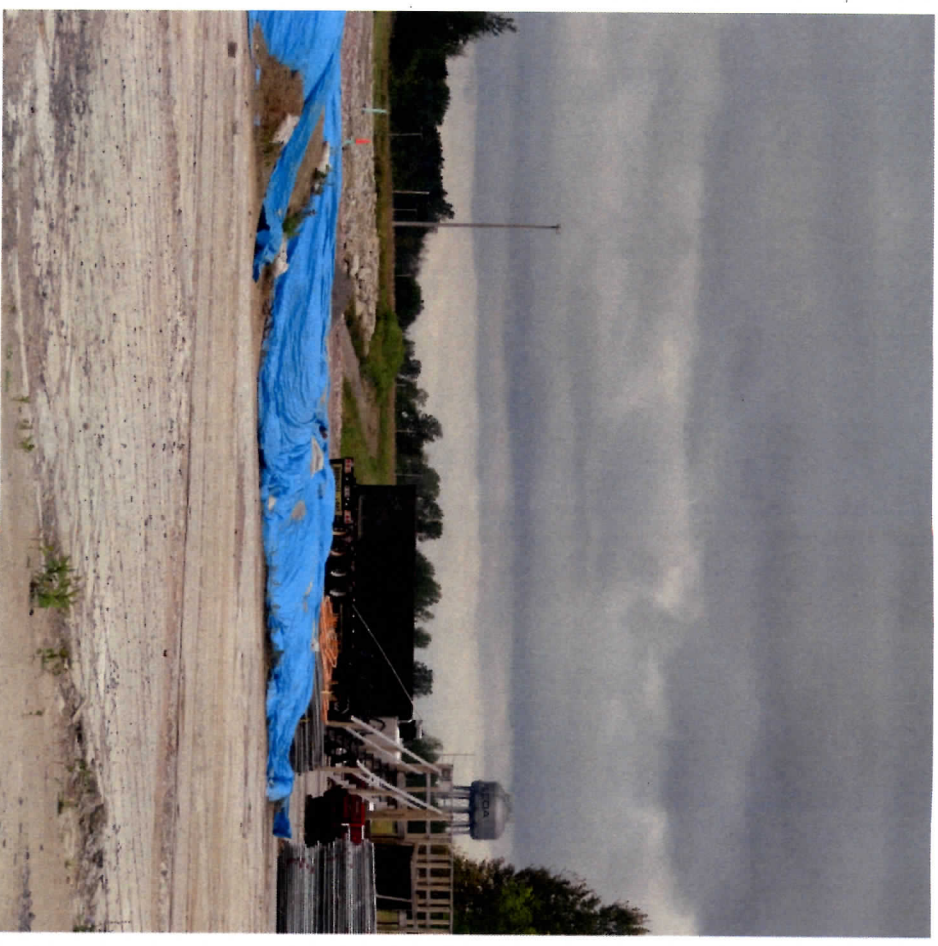
As shown in photos 911 and 912 there is a material storage pile with a blue tarp covering most but not all of the pile that was to be used for cover material by the remedial group. This material storage pile must be kept covered and proper erosion and sediment controls developed under its Best Management Practices (BMP) Plan Special Condition 4.A.11

DSCN4911 – remedial group cover soil – tarp not fully covering soil

DSCN4912 – remedial group cover soil – tarp not fully covering soil

(Erosion and Sediment Control and/or SWPPP. Arconic representatives said that they would make sure those piles are kept covered.
